SAFETY PERFORMANCE DISPLAY

ADD ON CRYSTAL ARMOR™ BULLET RESISTANT TRANSPARENTS

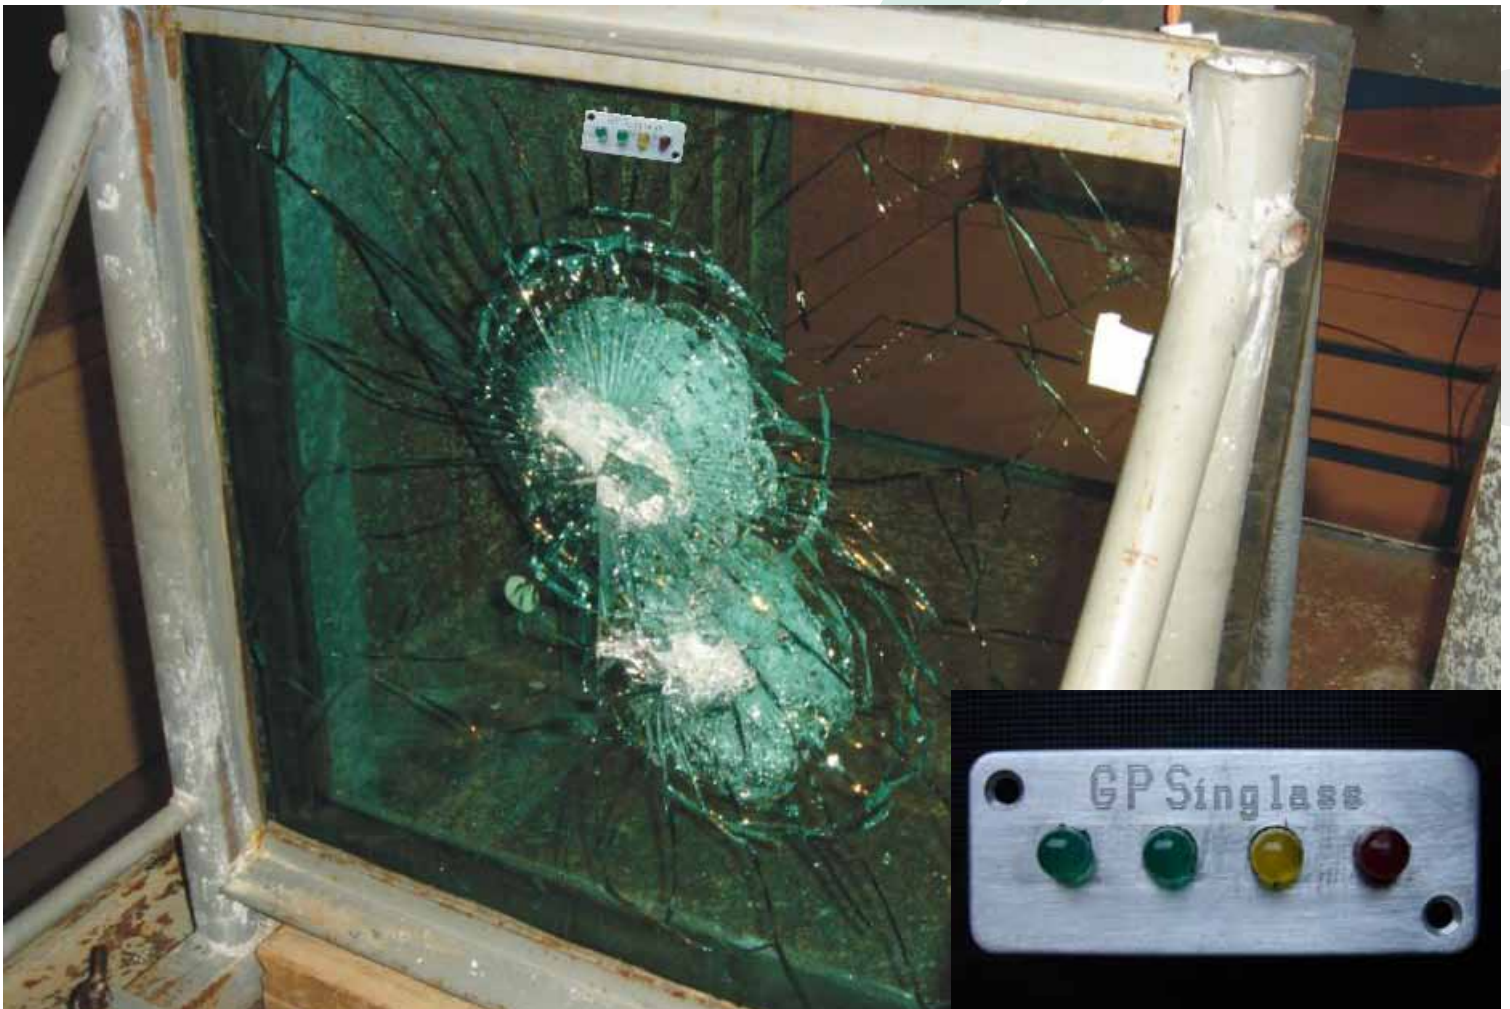
With the new patented “SAFETY PERFORMANCE DISPLAY” (SPD), a visual indication on a LED display, fixed on the inside of the glass, allows the persons in threat to determine the remaining degree of structural integrity of the window for fast and accurate decision making that might save lethal situations.

Information from sensor controlled interlayers inside the armored glass detects the depth of penetration and sends a signal to the display to show the remaining strength. This is displayed through clear color indicators: green (safe), yellow (compromised) to red (damaged).

In the event of an attack, with a SPD device a driver of an armored vehicle for example, can identify best to position a vehicle after being informed by the display should a certain window have been damaged.
